# Sham Recycling

Tyler Ginn  
LDEQ

# Facility Description

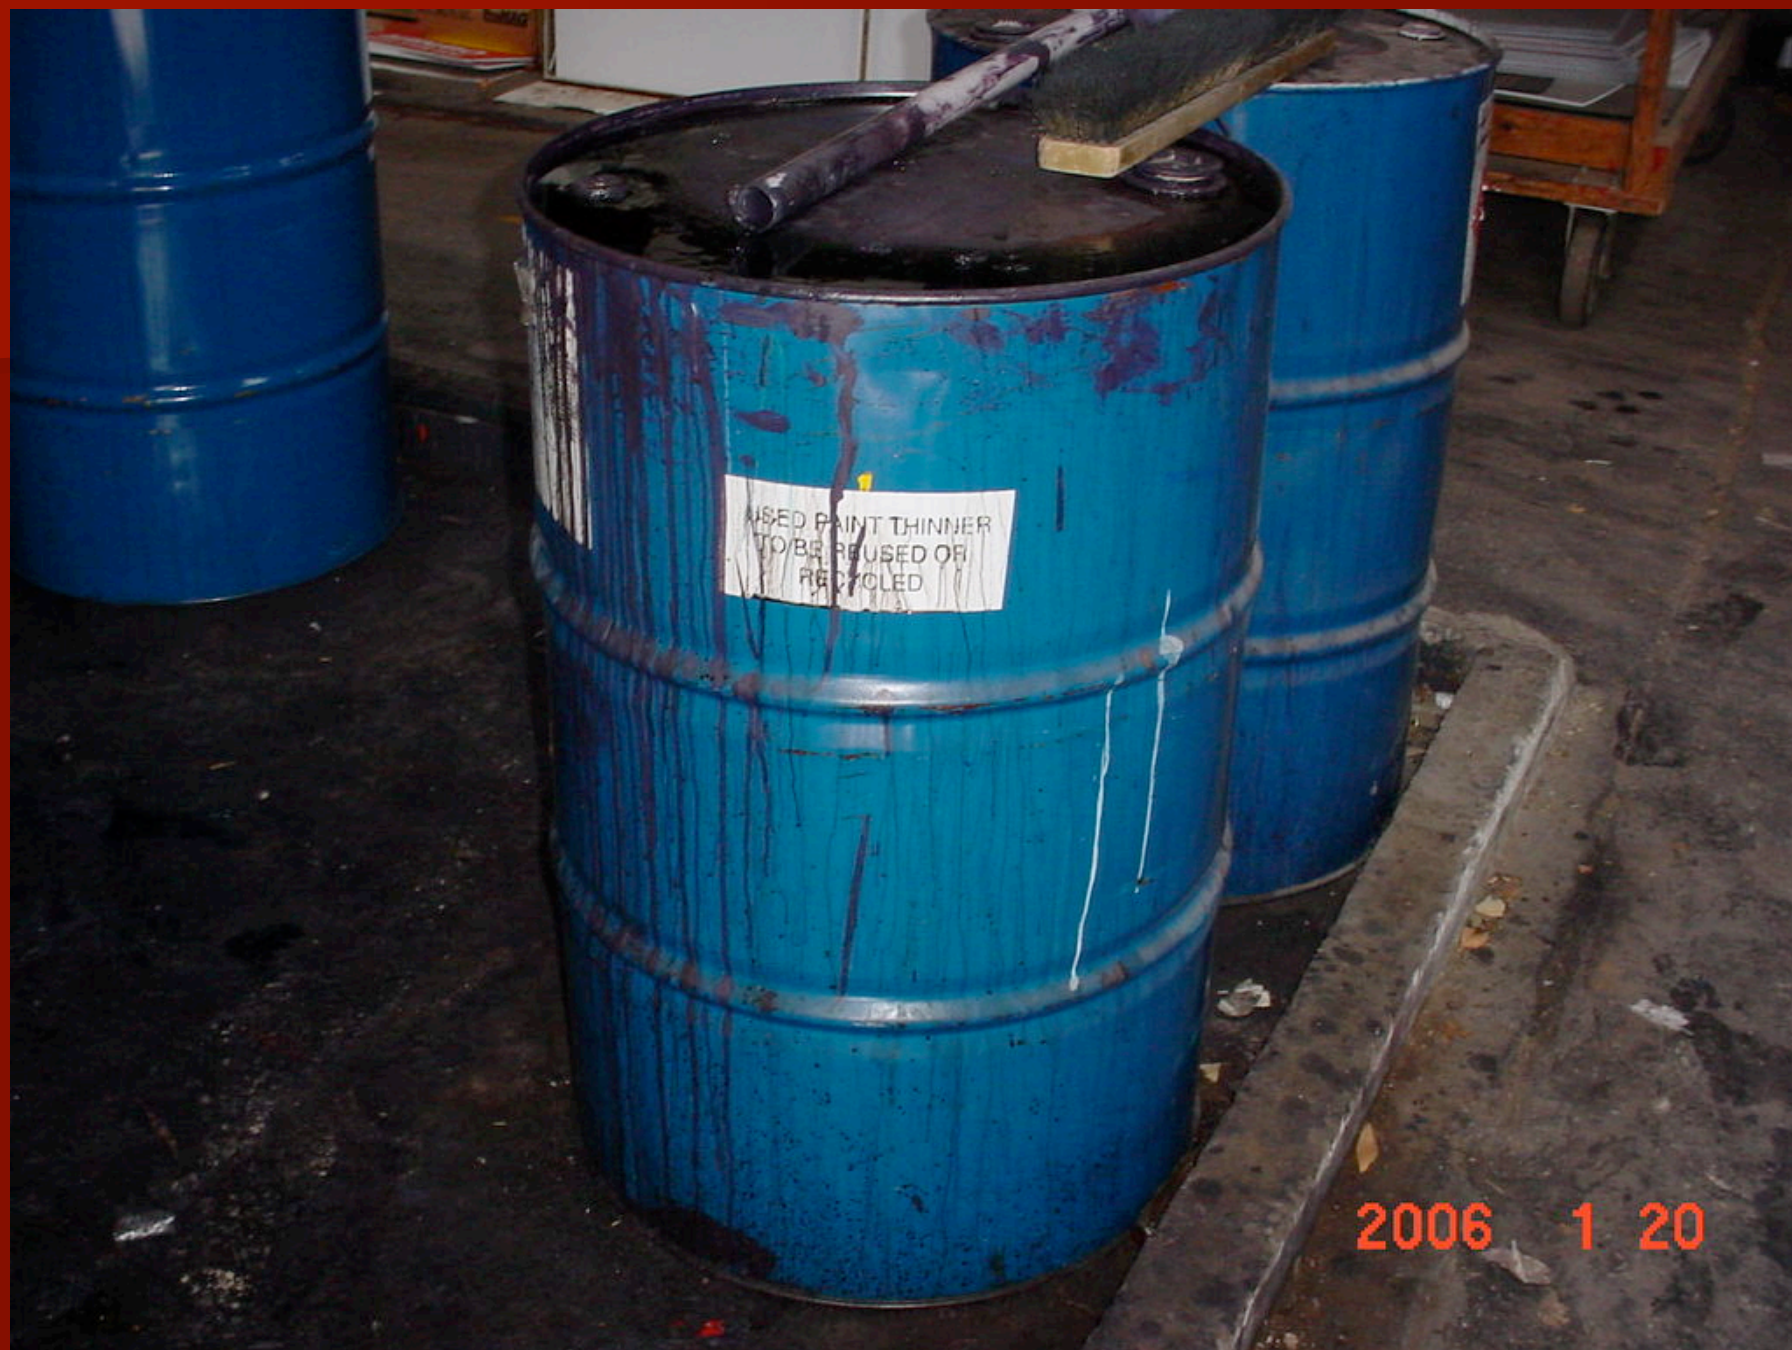
2006 3 29

- The master screens are hand washed using solvent stored in an open vat. The spent solvent and ink is collected in an open vat for reuse.
- The sludge in the vat is occasionally removed and placed into 55-gallon containers. These containers sit for several days to allow the solids to settle out.
- The top layer of solvent is transferred back into the vat for reuse. The bottom layer of solids is transferred to 5-gallon container. Eventually, the solvent becomes too saturated for reuse.

USED PAINT THINNER  
TO BE REUSED OR  
RECYCLED

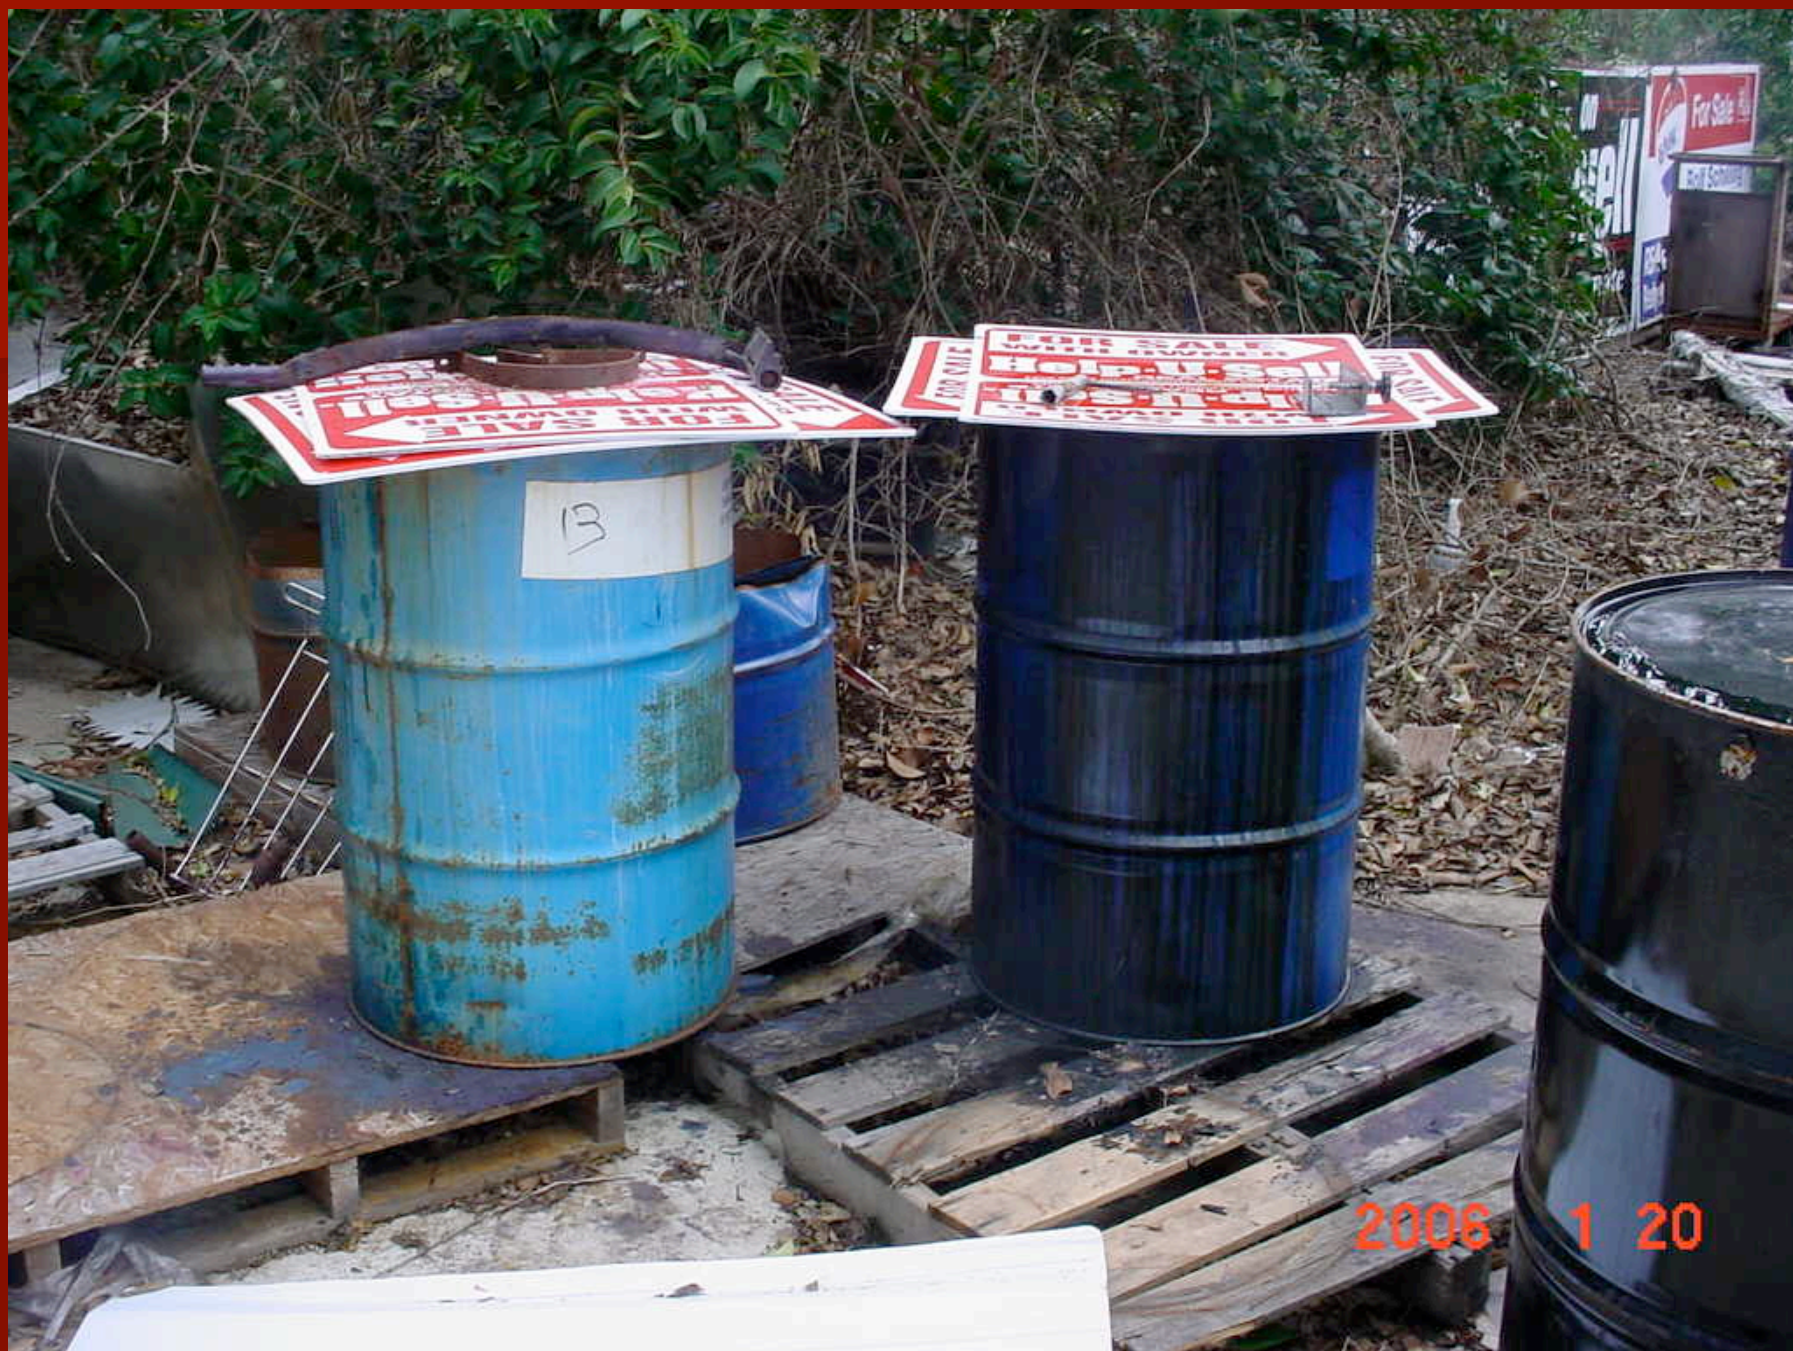
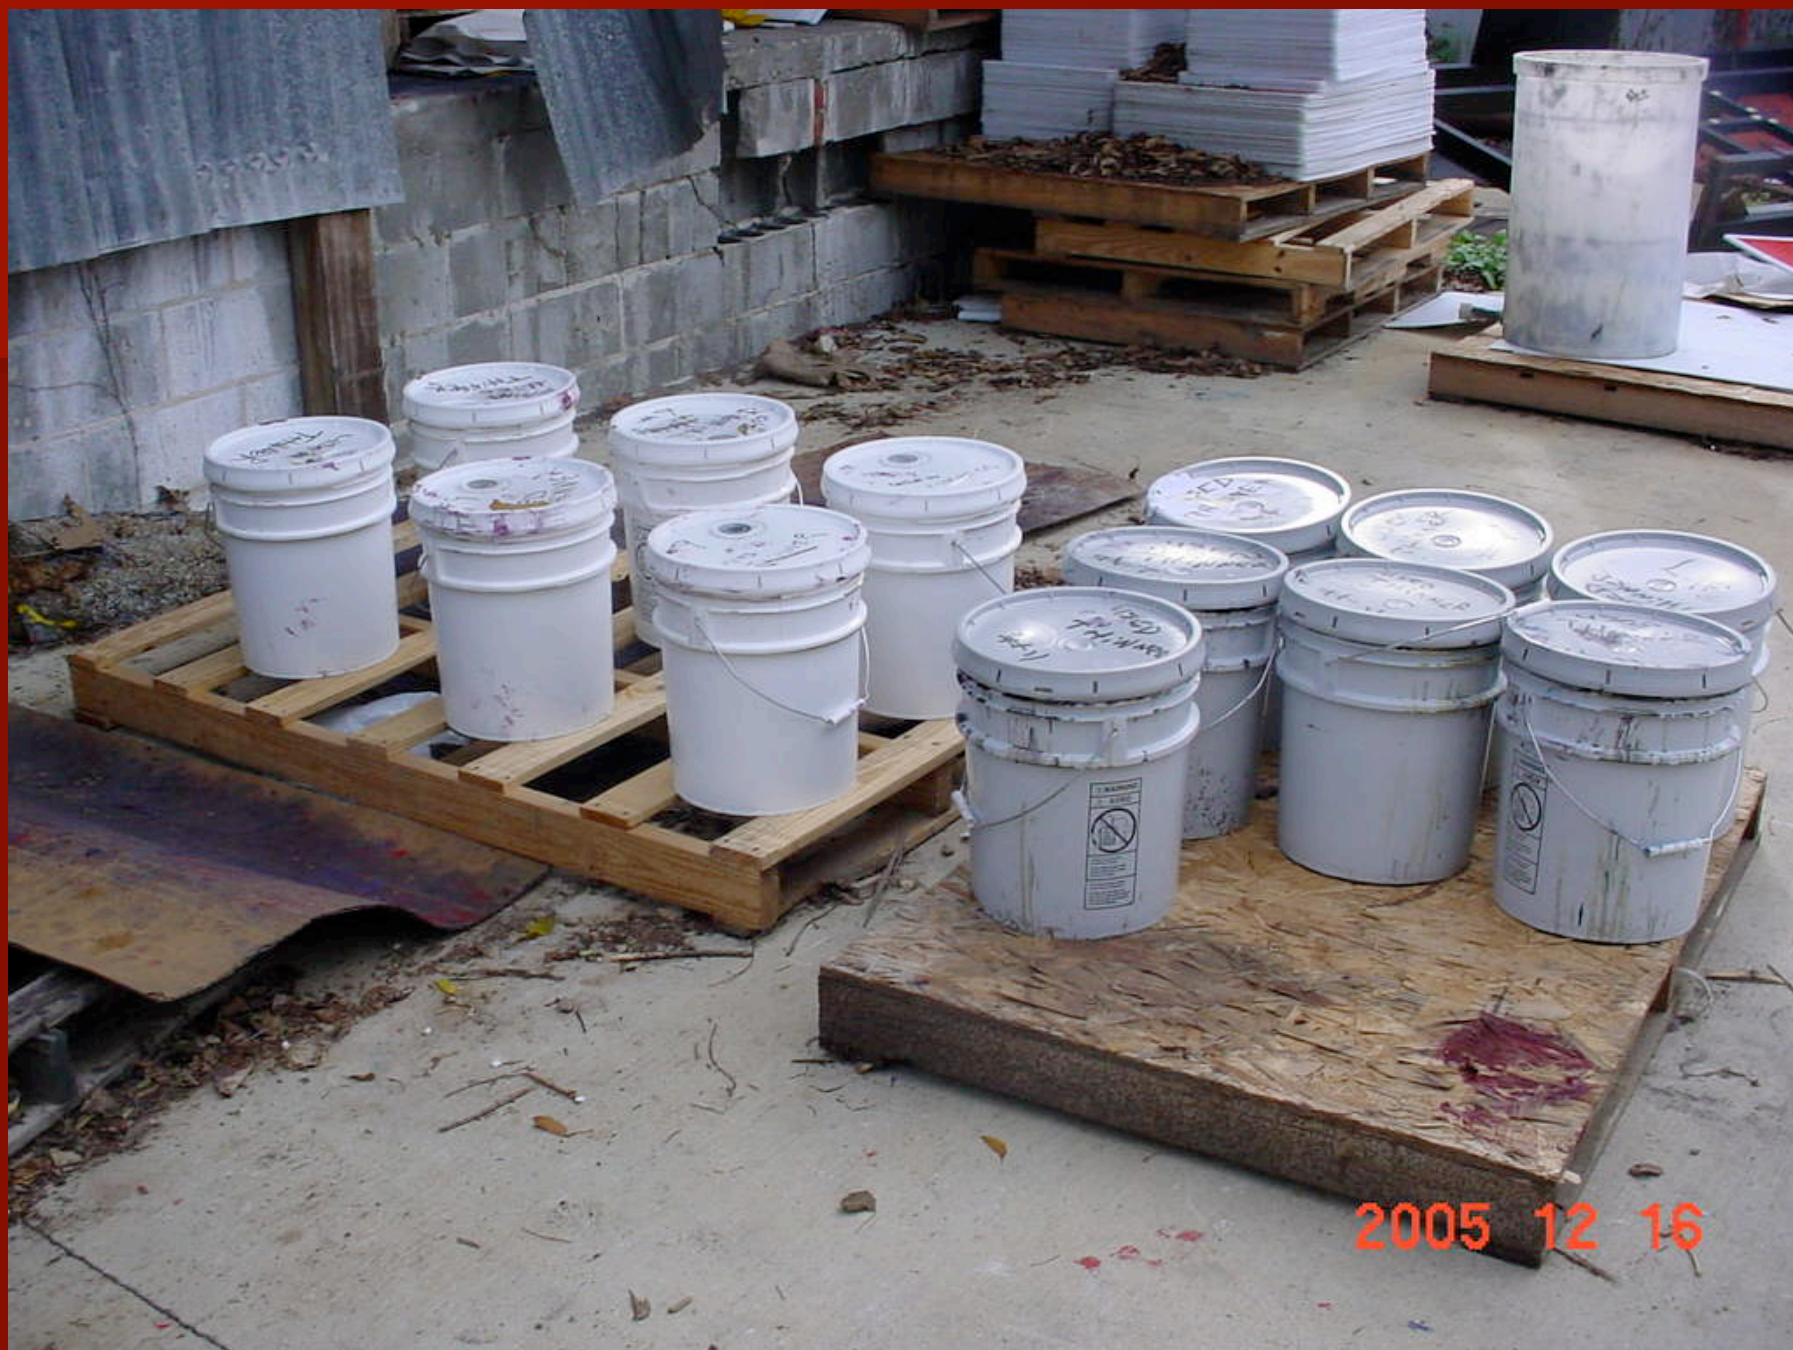
2005 12 16

- New inks and solvents are stored in closed containers inside an enclosed building.
- The material removed from the vat is stored in open containers that are covered with corrugated plastic.
- The ugly paint and used thinner is stored outside in closed, 5-gallon containers.

- All of the ugly paint and used thinner is fully regulated as hazardous waste (F003).
  - Need HW labels
  - Must be closed
  - Must transfer material from damaged containers into good containers.
- The criminal case is still pending.

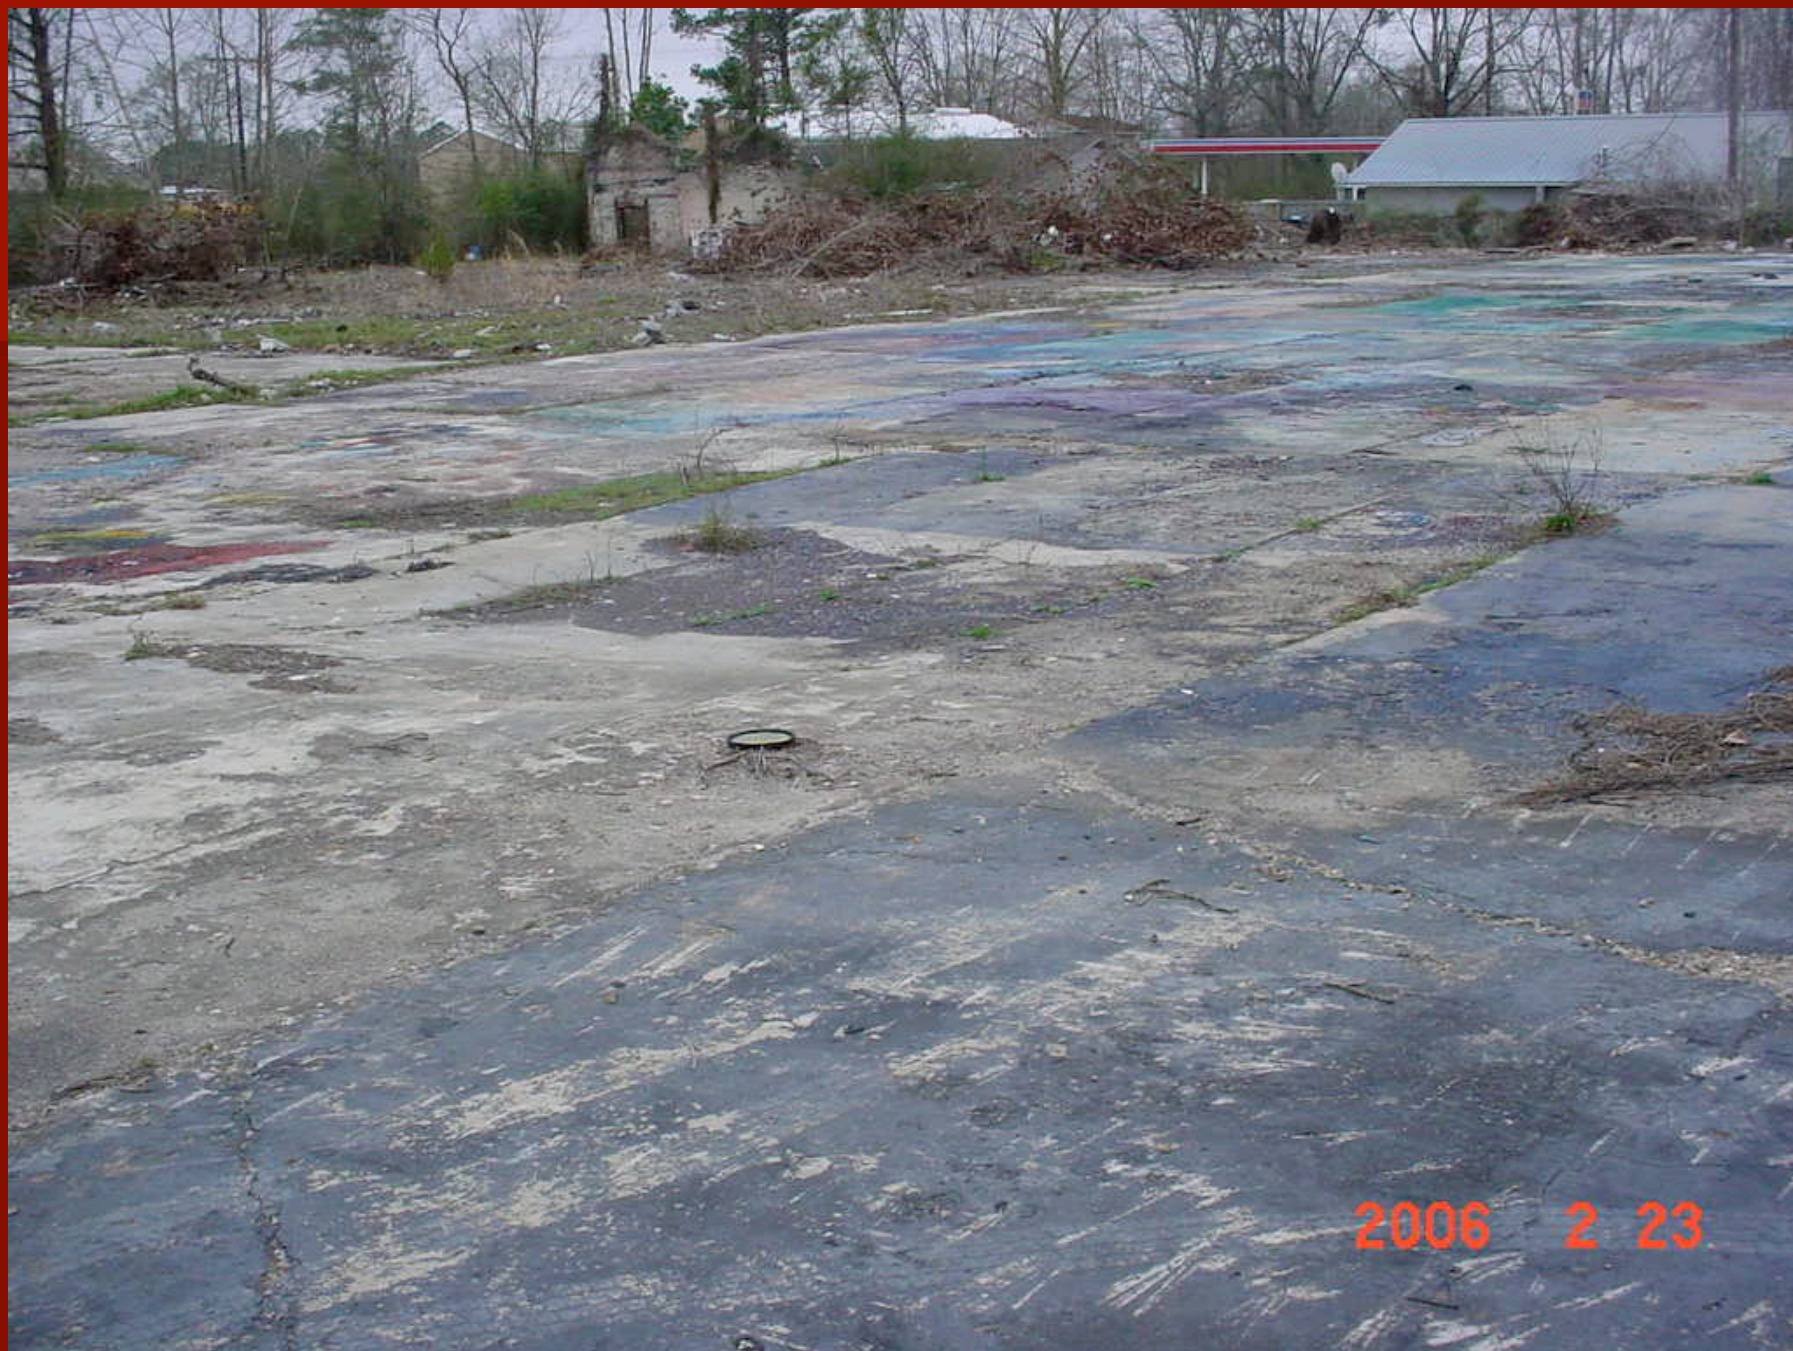
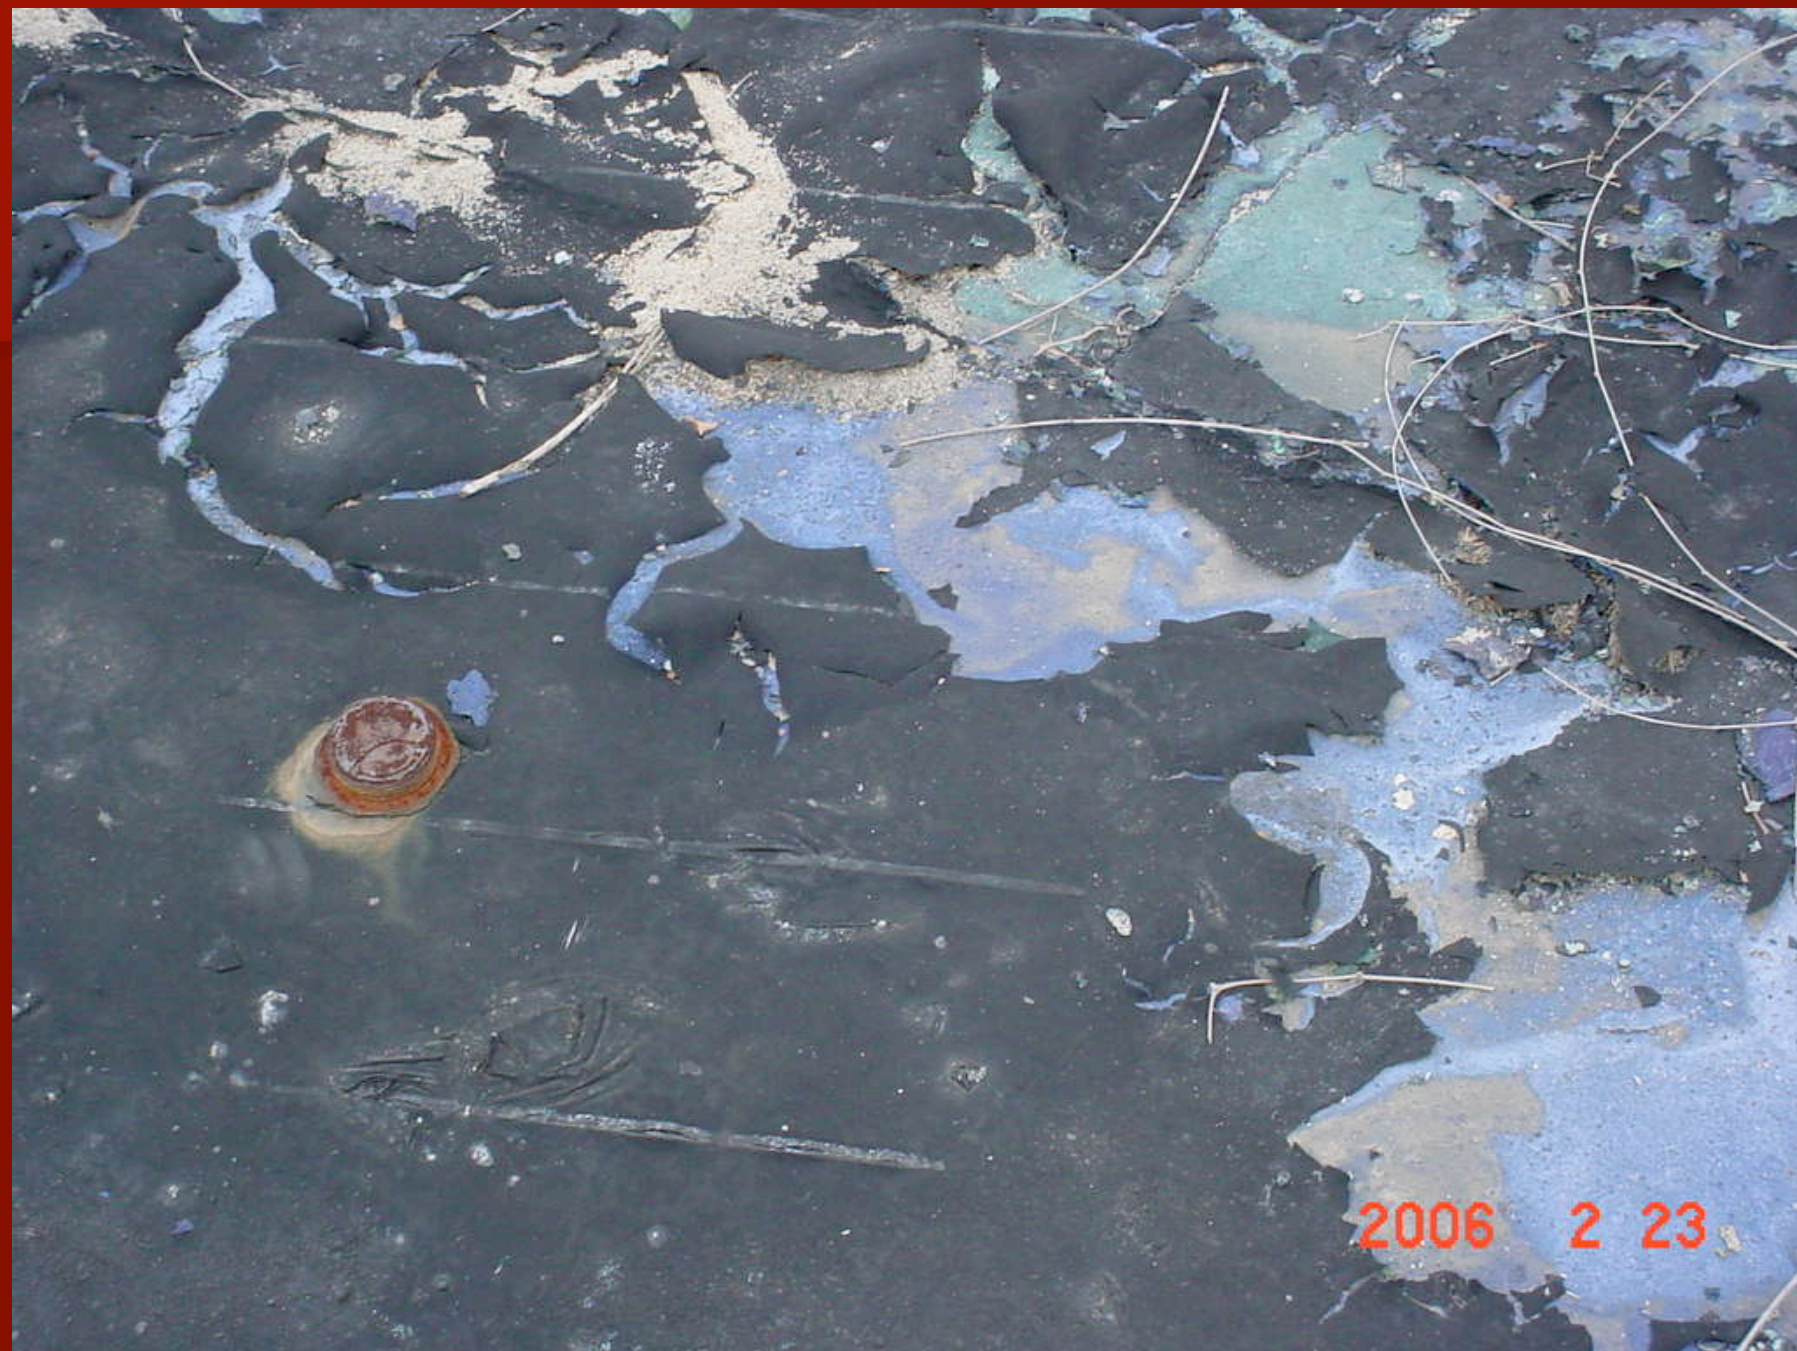
2006 2 23

- Not yet – The ugly paint and used thinner was actually dumped on a concrete slab down the road from the facility.
- According to the owner, he is painting an advertisement for his company that will be visible by airplanes. The advertisement is not complete.

- Transporting HW without a manifest.
- Transporting HW to a facility that has received an EPA ID#.
- Improper disposal of a HW.
